# Building Science and Physics vs. Architectural Sensitivity:

## *Design of Enclosures in the Most Hostile of Environments*

By Kipp Gaynor

*This paper was originally presented at the 2019 IIBEC Building Envelope Symposium.*

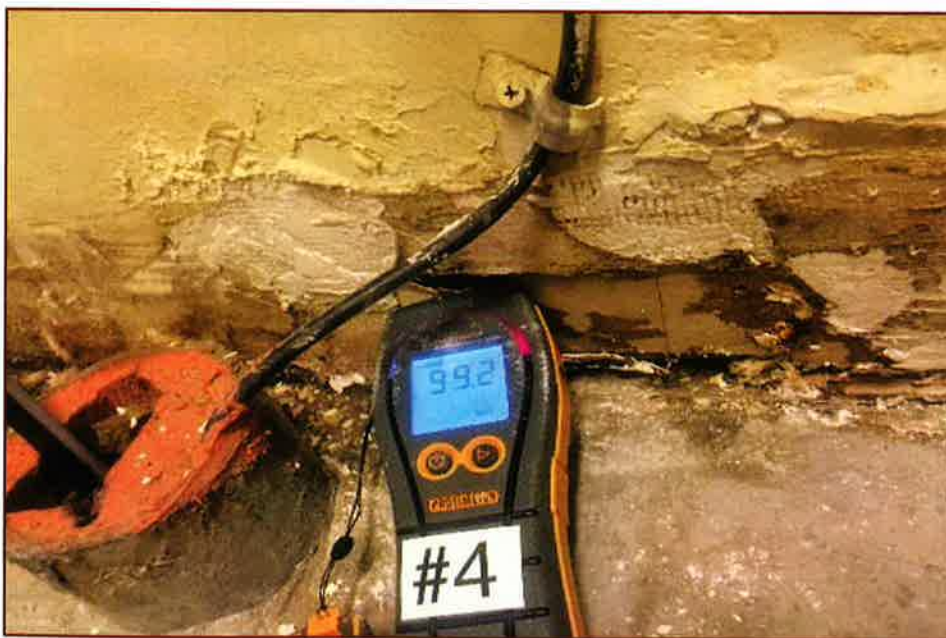
**Figure 3. Telephone closet at floor line. Note moisture reading during summer proposal visit.**

The telephone/communication closet area was heavily stained from previous water contact. The facer of the wall was delaminated along the base of the wall as well as the ceiling (refer to Fig. 3). In addition, a ½-in. plywood panel had been installed to the wall to receive the telecommunications equipment. This plywood concealed organic growth at the closet wall across the surface of the closet adjacent to the shaft area.

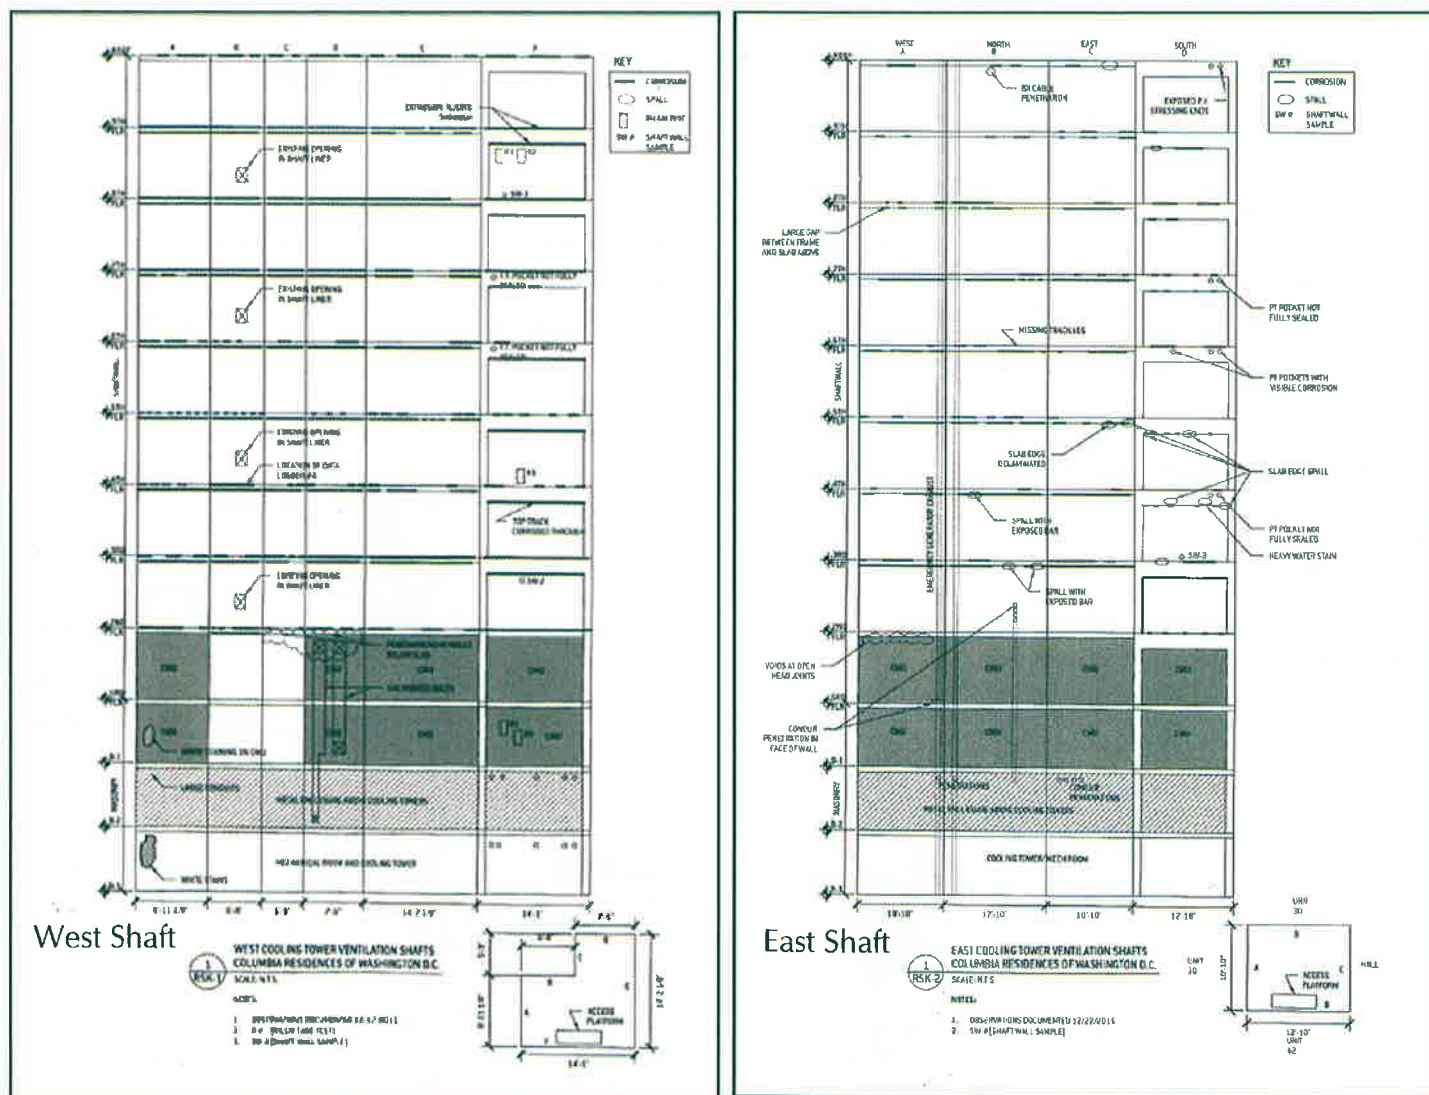
**Figure 4. Significant visual observations of shaft conditions from swing stage access (through vertical shaft).**

A number of significant conditions were encountered during the shaft survey performed from the swing stage. Refer to Fig. 4, which provides a schematic fold-out view of the wall planes observed in the two shafts.

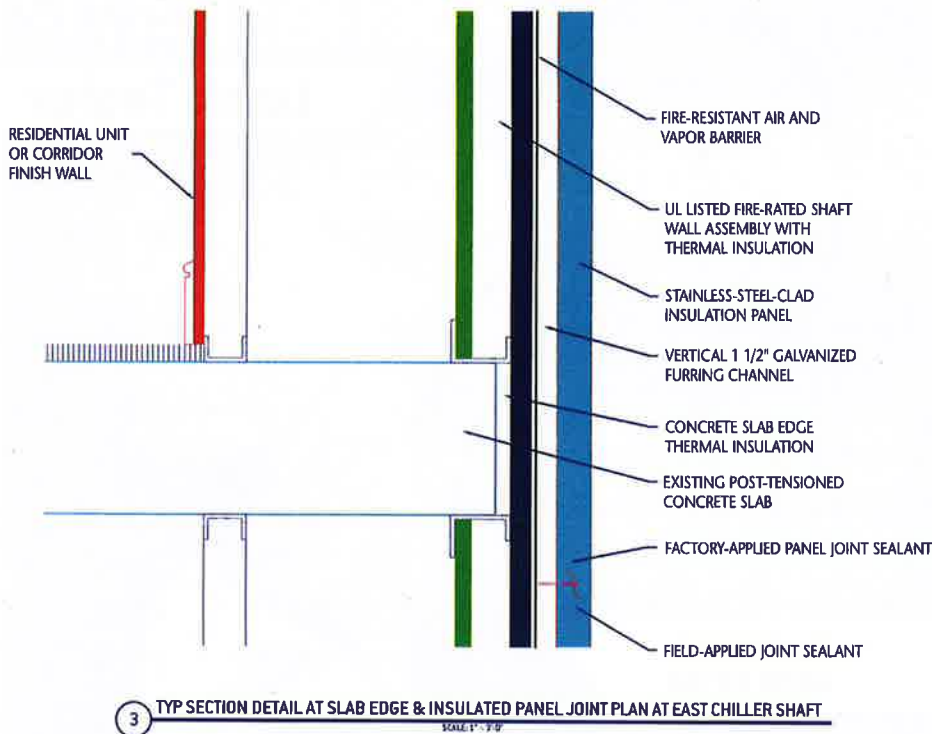
shaft wall assembly was encountered throughout the shaft. The metal framing of the shaft wall assembly "bucks" water that gravity causes to flow down the face of the wall, thus directing water to the inside of the wall assembly (Fig. 5).

Figure 5. As-built shaft wall section.

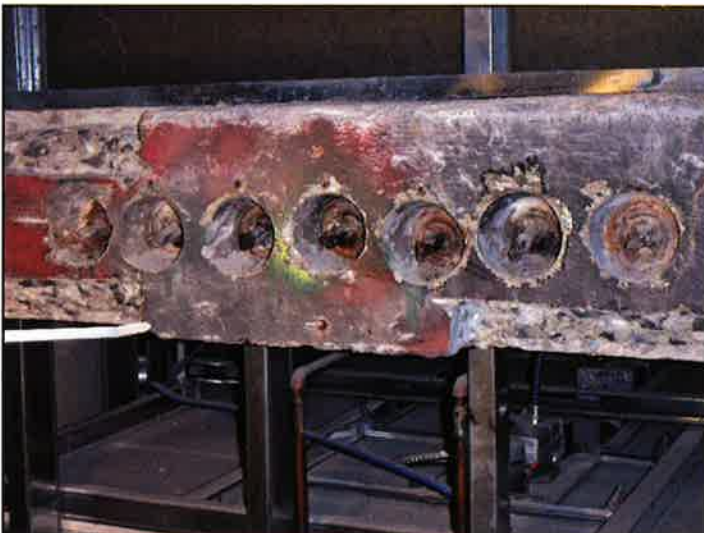
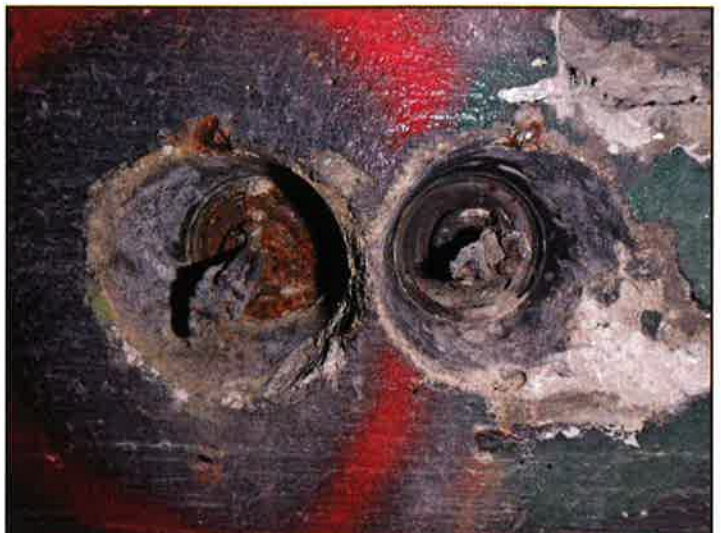
3. No transitional sealants or water management details at the exterior wall plane existed.
4. Concrete deterioration was visible along the slab edges (i.e., spalling, corrosion, exposed reinforcement, and failed post-tensioning pockets (Fig. 6A and 6B).
5. The light-gauge metal framing components of the fire-rated shaft assembly were experiencing significant cross sec-

Figures 6A and 6B. Post-tensioning pockets exposed and vulnerable to shaft environment.

The hallway walls were visibly distressed in the form of wrinkled drywall, cracked painter's caulk lines, and discolored wood crown molding (refer to Fig. 6A). Demolition of the hallway wall finishes revealed significant organic growth along the backside of the hallway wall-board.

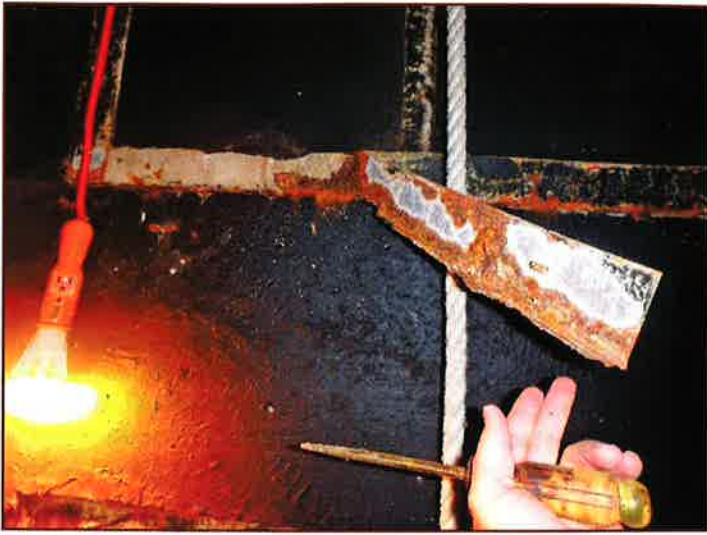
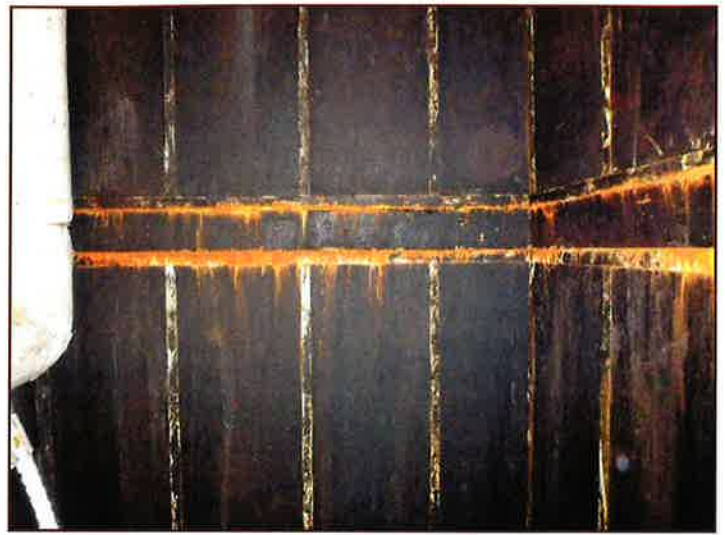
tion loss. The metal was so severely corroded in areas that portions of the galvanized steel sill and head tracks could be removed by hand (Fig. 7A and 7B).

**Figures 7A and 7B. Severe corrosion of sill and head tracks encountered at various floor lines.**

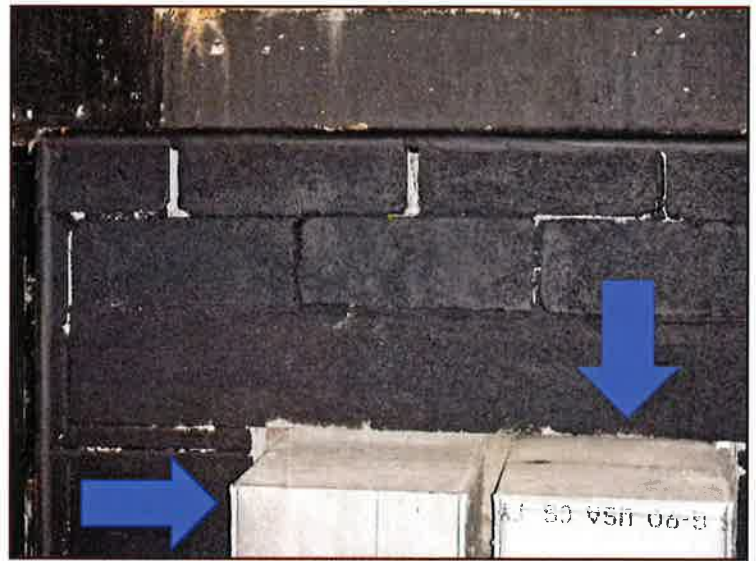
sions for robust air sealing of the shaft wall system created the pathways for moisture-laden air to compromise the corridor wall finishes (Fig. 8 and 9).

**Figure 8. Fire-rated masonry wall separating shaft area and commercial/first-floor level. Note supply and return ductwork inside shaft with unsealed wall penetrations (see blue arrows).**

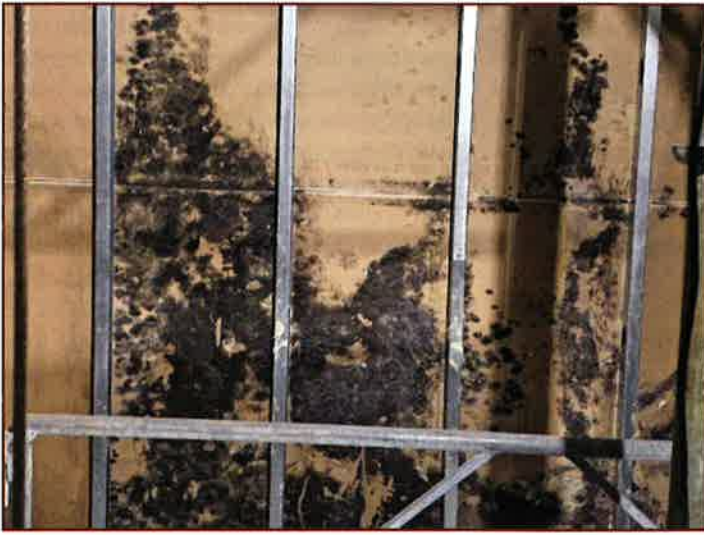
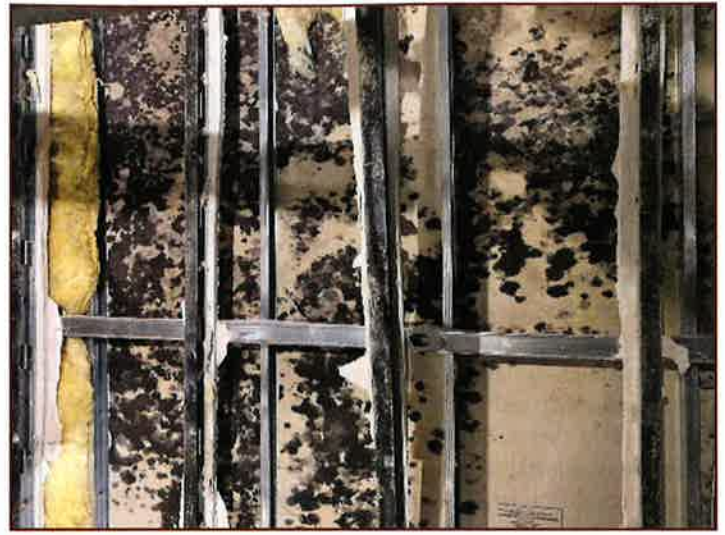
The condition of the demising wall framing and the paper-faced gypsum wallboard separating the shaft wall and the residential units was not well defined prior to the construction, and allowances for remediation were budgeted into the project. The incidence of organic growth

**Figures 10A and 10B.** Organic growth was encountered at various locations on the cavity side of the demising partitions that required abatement.

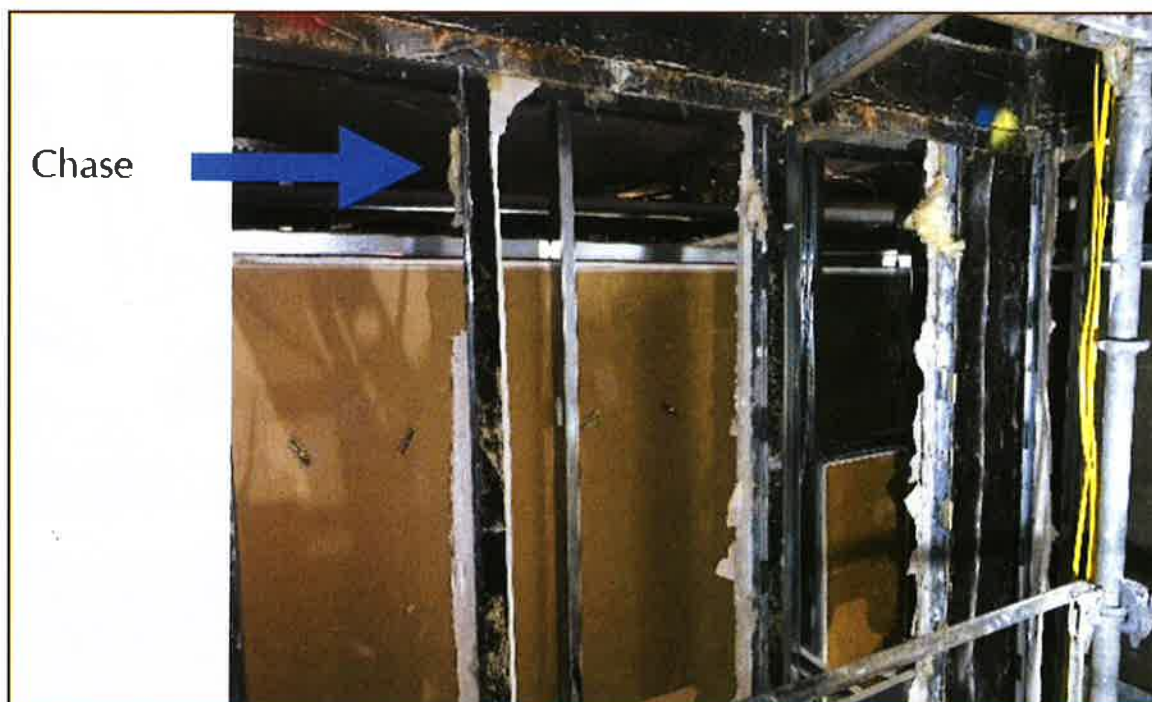
**Figure 14.** Fire-rated shaft wall has been removed, but framing remains. Note the ceiling chase area that extends across the ceiling of the ninth-floor units creating challenges to maintain negative pressurization.

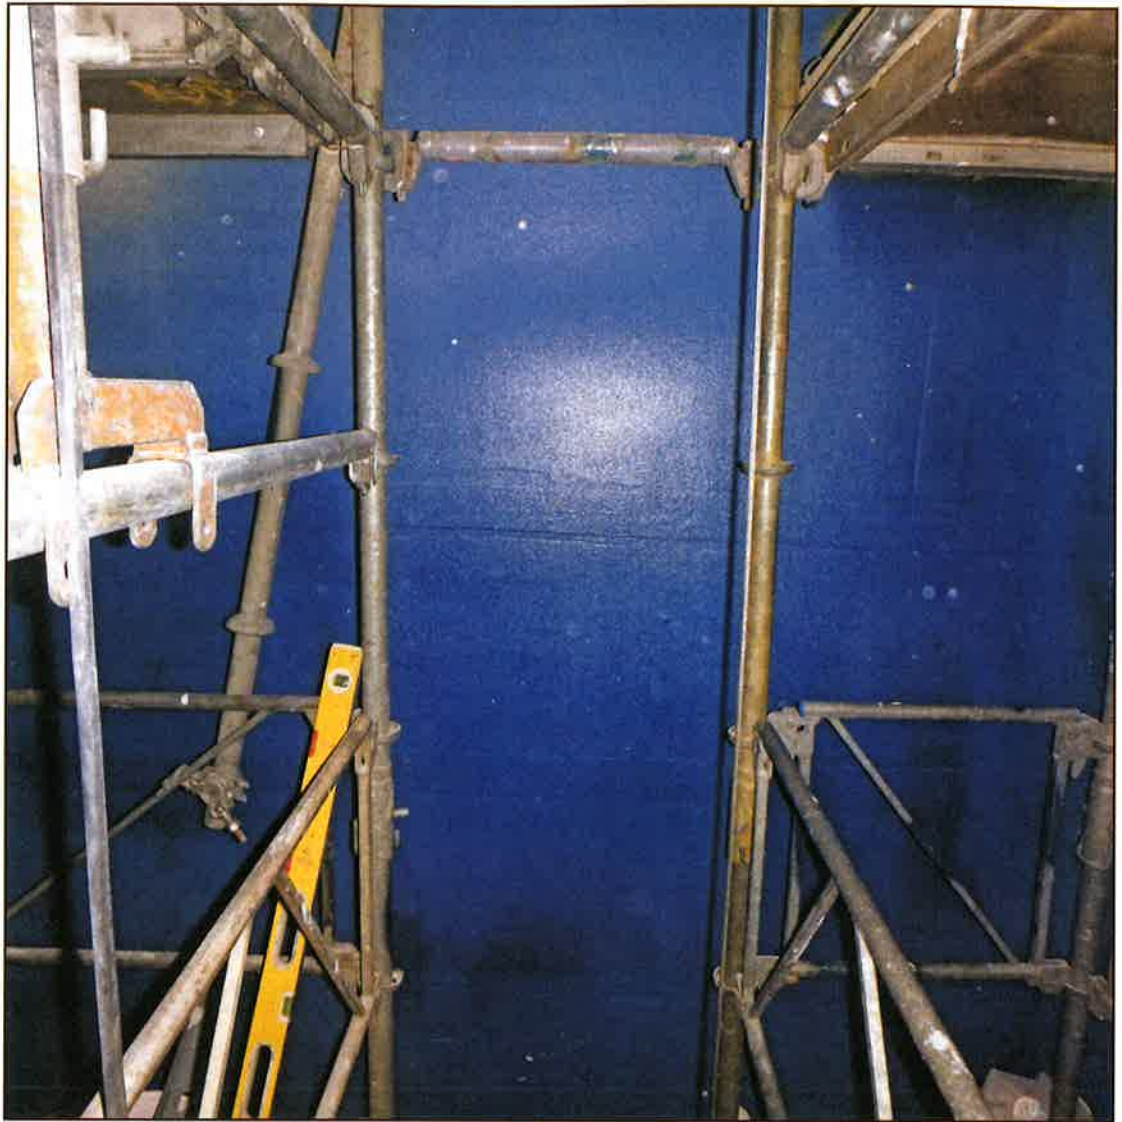
1. Due to the scaffolding configuration and restricted space during construction, the workspace was severely limited and did not accommodate inspector access alongside the installers when many of the critical details were being implemented (Fig. 15). Limited line-of-sight access further hampered visual observation of the critical butyl sealants and their continuity.
2. The sealant work performed at the insulated metal panel systems' mending plates and cover plates was produced at a very fast pace, which made it difficult to field-verify the work in

*Figure 15. Note the limited physical access between the scaffolding and shaft wall plane. Note the continuous blue air and vapor barrier.*
