# Building Science and Physics vs. Architectural Sensitivity:

## *Design of Enclosures in the Most Hostile of Environments*

By Kipp Gaynor

*This paper was originally presented at the 2019 IIBEC Building Envelope Symposium.*

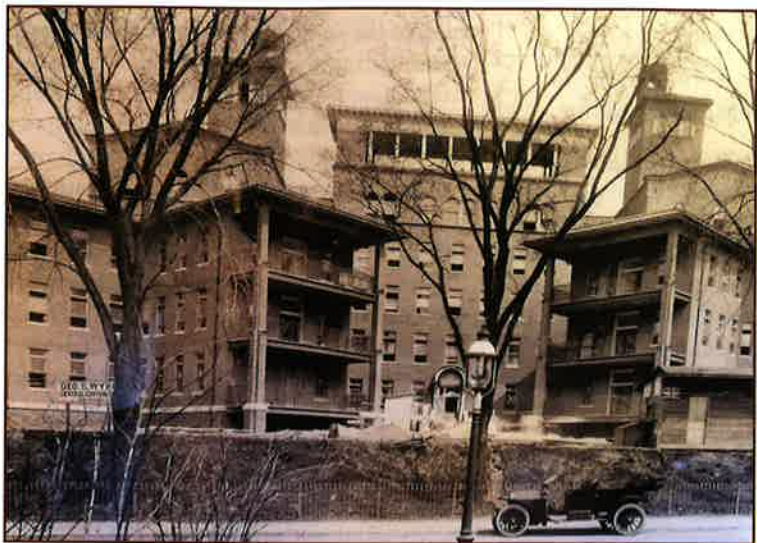
**Figure 2. Columbia Hospital for Women.**

The property features three prominent wings. The center wing was formerly the Columbia Hospital for Women, an ornate and historic Italian Renaissance-style structure with terra cotta tile, limestone, and tapestry brick that was built circa 1916 (see Fig. 2). It was repurposed into a very attractive luxury residential condominium located in the center of Washington, DC's high-end residential real estate district.
